R 197

COATING STUDIES AT KWAJALEIN,
KANEHOE, AND PORT HUENEME

2 July 1962

OBJECT OF TASK

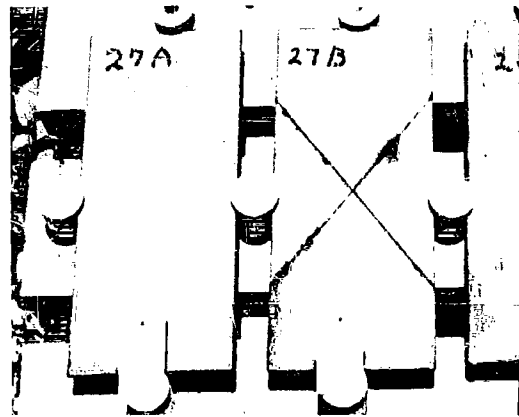
Kwajalein, 2-1/2 years

After 2-1/2 years at Kwajalein, white zinc salts had formed over about 10 percent of the surface; however, no rusting had occurred along the scribed mark or on the unscribed surface and the overall protection was rated 10. Zinc salts had formed at minute blisters; blistering over the surface of the two panels was rated 8/M.
